SPARC Radiation Tolerant Processor Chip Set (CDA) Design Considerations List

This document describes the current identified specification deviations (as off June 15, 98) for the TSC691E (rev C), TSC692E (rev D) and TSC693E (rev A), with a work around proposal, when available.

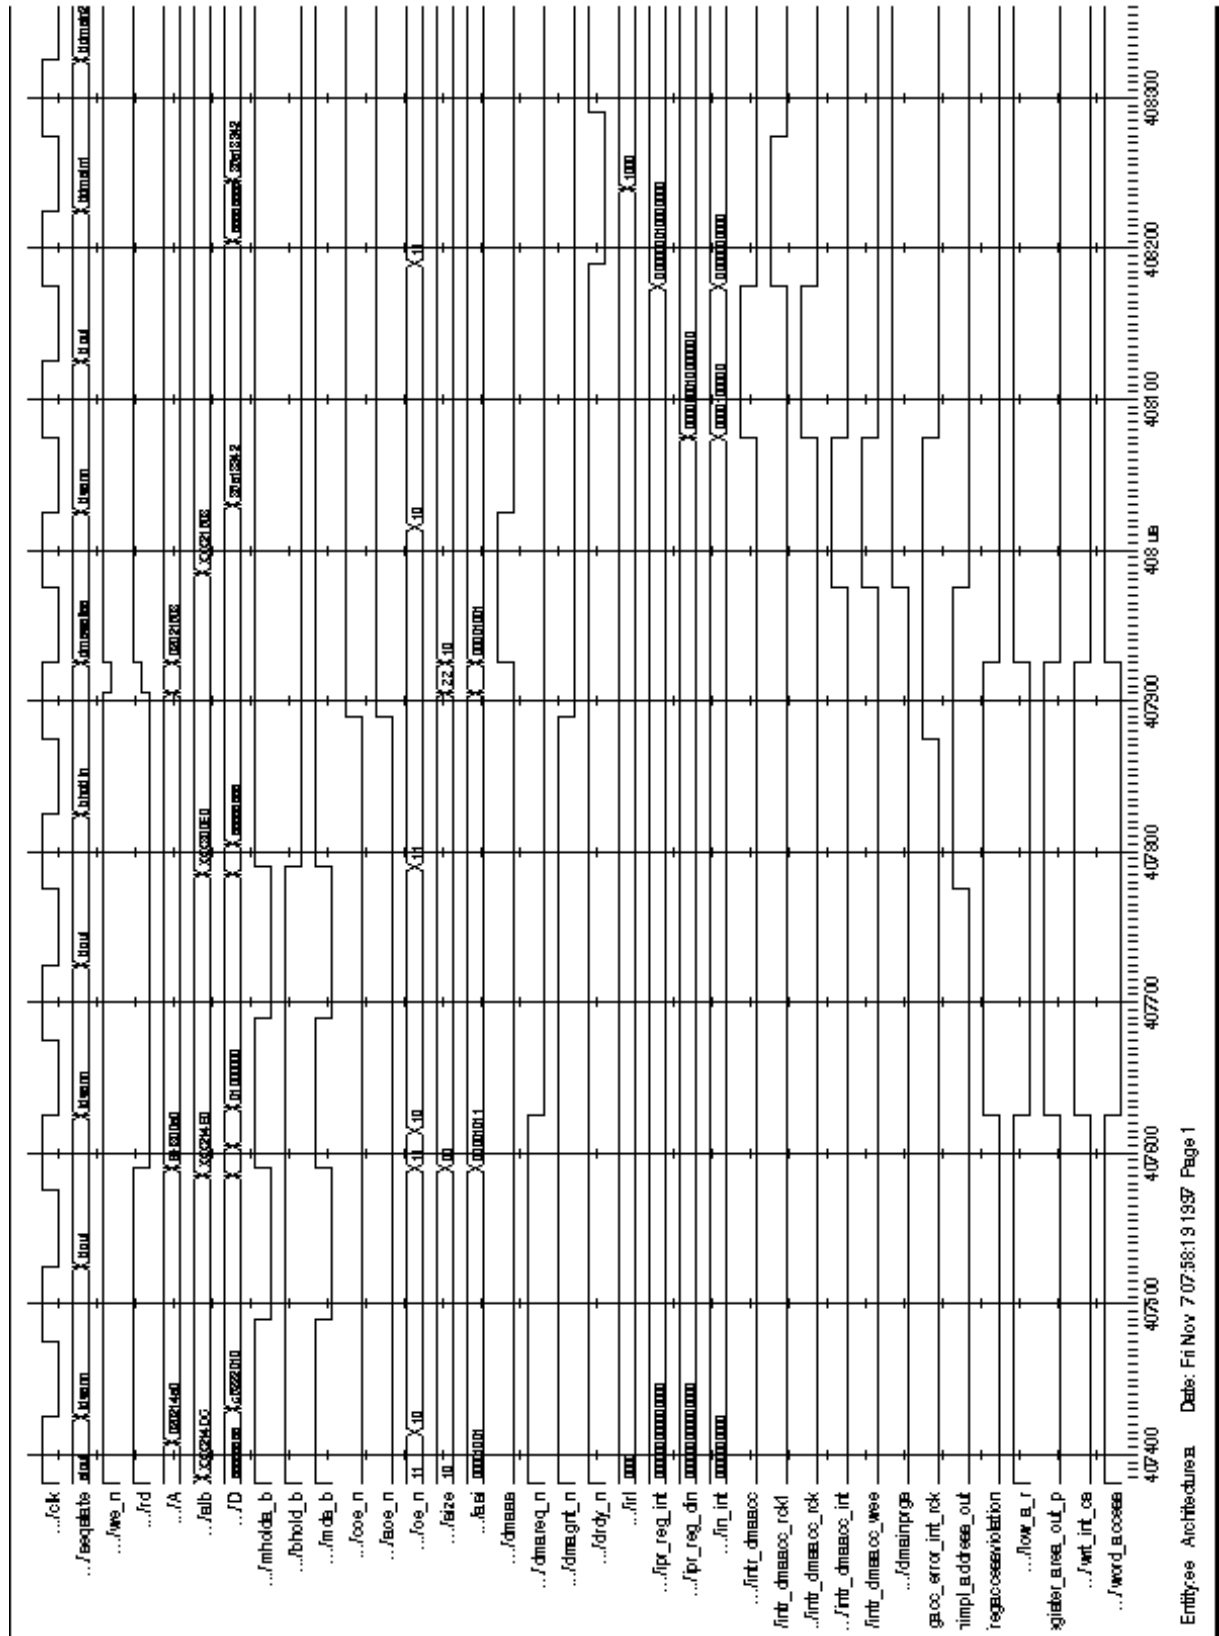
When a DMA access aborts an illegal store byte to a TSC693E register, the TSC693E register access violation leads to a DMA access error: IRL is set to 8.

```
stb %g0,[%g1 + 0xe0]
```

with [%g1 + 0xe0] addressing TSC693E UARTA register is aborted as shown on the following timing diagram.

The TSC693E did not record the context in which the register access violation occurred, that is an IU access, and propagated the error through the DMA access context, triggering a DMA access error.

No Workaround known.
