LEON-PCI-UMC Development Board

Test Report

GAISLER RESEARCH / PENDER ELECTRONIC DESIGN

Rev. 1.2, 2004-04-02

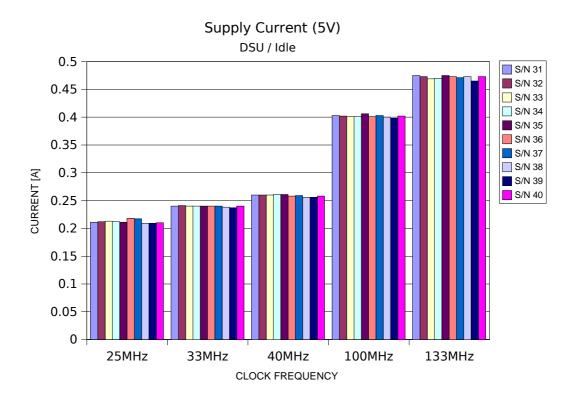
Figure 2-1: Board Supply Current Versus Frequency (processor halted)

Measurements of the operational current required by the board were made for all devices at several clock frequencies, as graphed in the following figure. This is the current measured at the input to the board, and includes both the quiescent and active current of the ASIC plus the current of the Memory/Peripherals.

Based on the above measurements, the calculated standby current of the board is estimated to be about 140 mA, while the current consumption of the Leon chip is about 2.5 mA/MHz. (equivalent to 4.5mW/MHz for 1.8V core voltage).

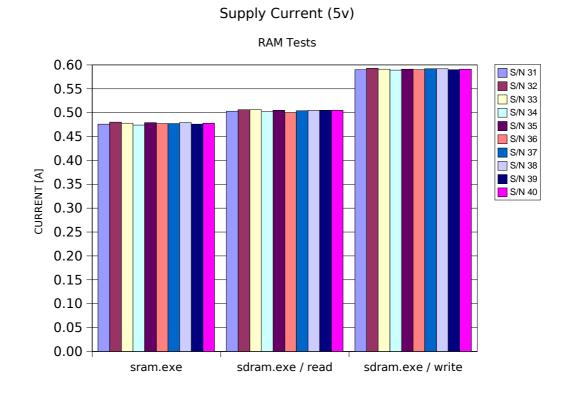
Figure 2-2: Board Supply Current versus Type of Memory access (100MHz)

The Leon chip has very little difference between power-down and full load. Most extra current when running programs comes from the memory - a program with

100% cache hit (and no memory writes) only consumes about 10% more current than the power-down mode (even with a high FPU load). As the power consumption of the memories, being the main contributor to the device's power consumption, seems to depend on the clock frequency and is mostly independent of read/write cycles being performed, some attention should to be paid to the design of memory power down modes for future designs.

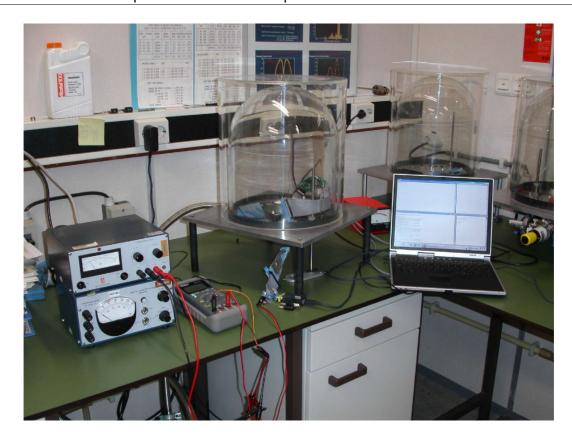
Figure 3-1: ESTEC Californium SEU Test Set-up

The test equipment consists of the following items as shown in Figure 3-1:

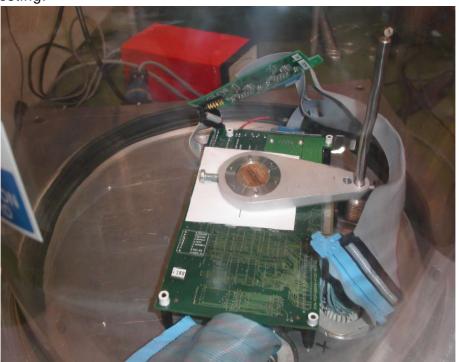
Figure 3-3: Cf-252 source placement above die cavity

The Californium test source used was labeled as 480-87-1A with an indicated activity of 1.781uCi 27 April 1995). The corresponding flux was calculated to be 800 particles/cm²/min at 1.5cm distance. All testing was performed at normal incidence to the die. The mean LET value for all fission particles from the Cf source is given in literature as 43 MeV.mg⁻¹.cm²
